RE: Site Inspection, GoldTerra, Black Butte Mine, S/015/080, Emery County, Utah

Date of Inspection: March 28, 2003  
Time of Inspection: about 3:50 to 4:30 p.m.  
Conditions: Mostly clear 40's  
Participants: Paul Baker (DOGM)

**S/015/080, Black Butte Mine, GoldTerra**

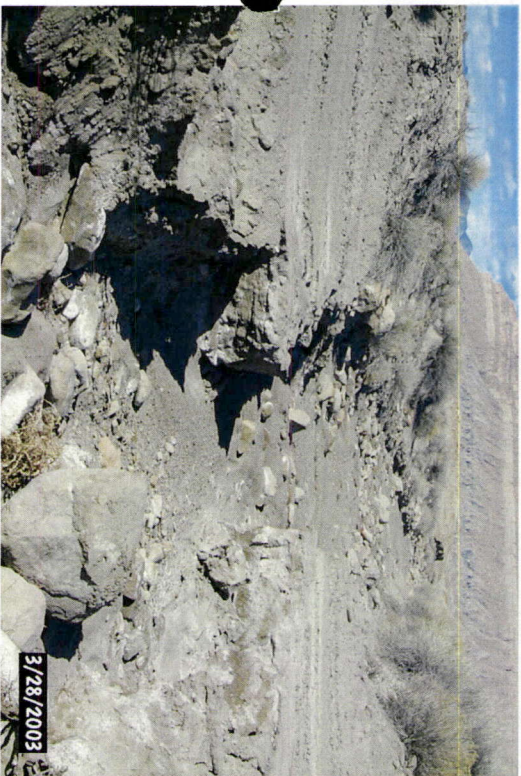
**Photo 1. The first crossing.**

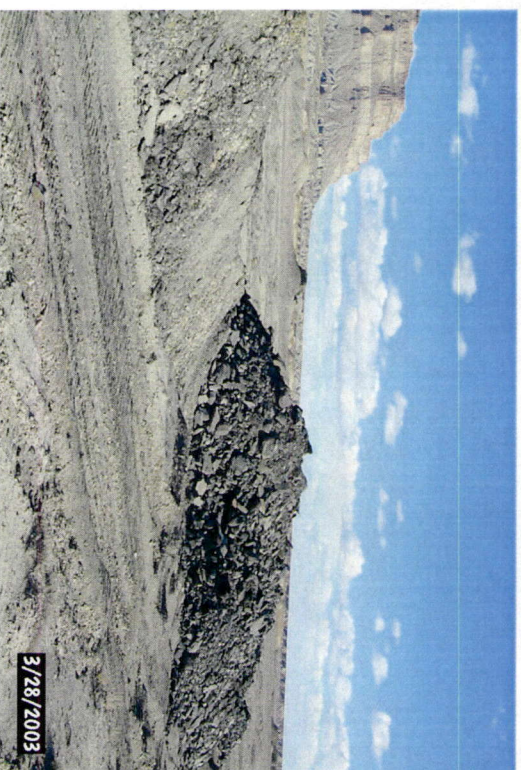
**Photo 3.**

The site consists of an excavation about, as I recall, fifteen feet deep with material from the excavation placed to the side (Photos 3 and 4). The site is in Mancos shale, so there is little vegetation. There are a few places where people have driven in the mine area, and the total disturbance is about one acre not including the access road.

There is very little vegetation at this site, and I'm not sure there is anything that could be considered soil that is worth salvaging. In reclamation, the more coarse material should be placed in the pit first with finer material put over the top. If the site is left extremely rough, there is a chance for some vegetation to grow.

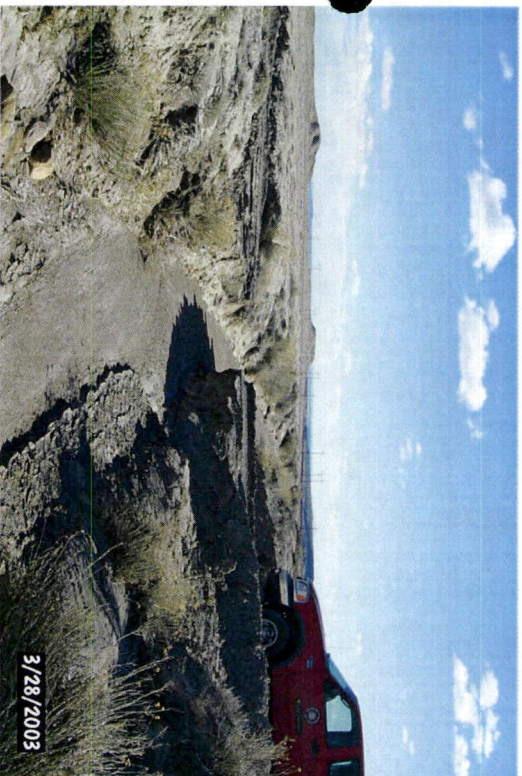
The notice of intention says the proposed new road will cross two moderate sized drainages and that culverts will be installed in these drainages. The first of these locations is shown in Photo 2; there is obviously no culvert. I do not remember whether there was a culvert at the second crossing. To be in compliance with the notice, the operator needs to install these culverts.

**Photo 2. The second crossing. I was not able to drive this one.**

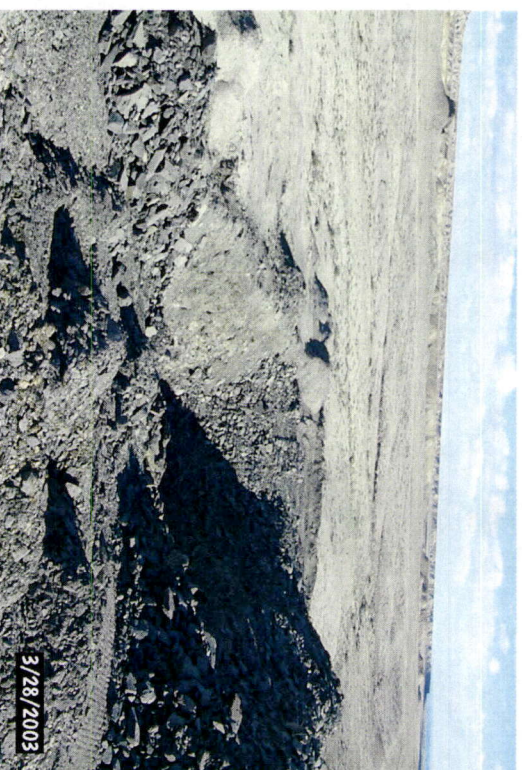
**Photo 4. The excavation and some of the excavated material.**
